Maintenance Actions to Address Fatigue Cracking in Steel Bridge Structures

PROPOSED GUIDELINES AND COMMENTARY

NCHRP Transportation Research Board of
The National Academies

Robert J. Connor and Jason B. Lloyd
Purdue University
West Lafayette, Indiana

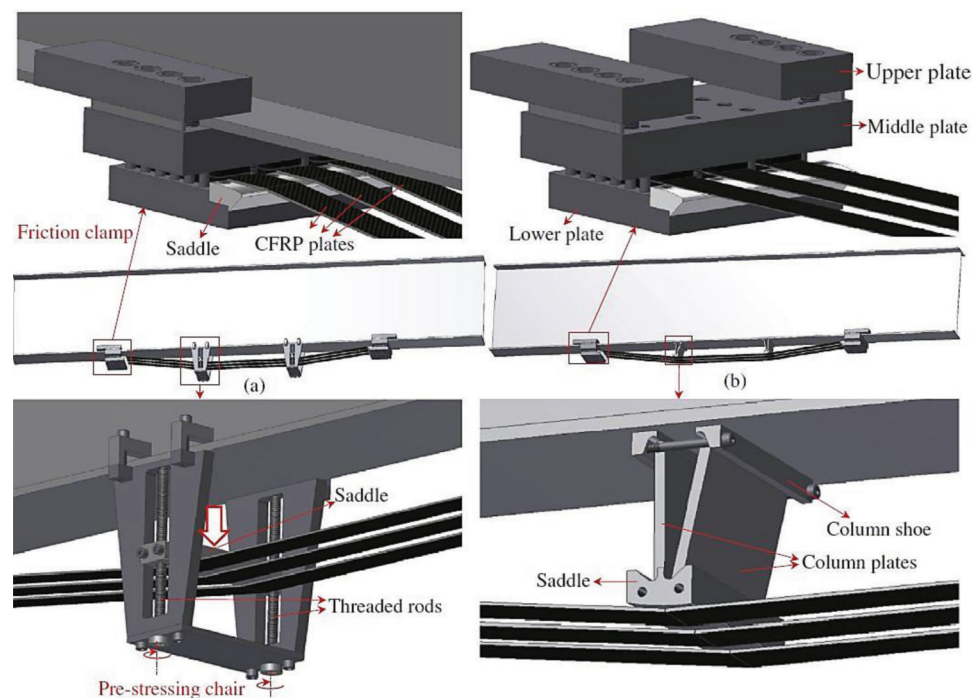
Figure 8.5 Components of the PUR system (Taken from Ghafoori *et al.*, 2015).

Of particular interest for this guideline was a study by Ghafoori *et al.* (2015) that installed a pre-stressed un-bonded reinforcement (PUR) CFRP system on a 120-year-old railway bridge in Switzerland. The concept of the study was to install a form of CFRP that would not require preparation of the steel surface for an adhesive bond layer, reducing installation efforts. The PUR system uses an applied pre-stress force to reduce the mean stress and shift an existing fatigue detail from the “at risk” finite life regime to the “safe” infinite life regime, functioning much like external post-tensioning. Figure 8.5 is an illustration that comes directly from Ghafoori *et al.* (2015) showing the components of the PUR system; the friction clamp that holds the ends of the CFRP plates, pre-stressing chair used to pre-stress the CFRP plates and create an eccentric load (and induced negative moment) on the existing steel member, and the column plates used to hold the CFRP plates in position once they are pre-stressed. An added benefit to the system is that it can be installed between rivets without needing to drill holes or remove coatings. The actual

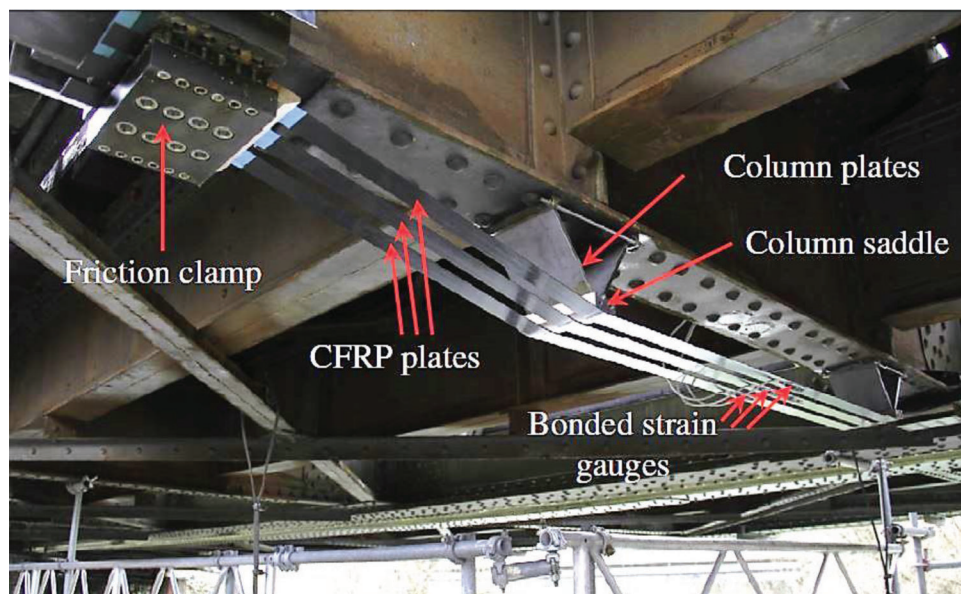
Figure 8.6 Strengthened floorbeam using PUR system (Ghafoori *et al.*, 2015).

system installed is shown in Figure 8.6, showing the three CFRP plates and other PUR system components.

Strain gages, as well as sensors for monitoring relative humidity and temperature, were installed on the bridge. They observed the following during the short-term field testing:

1. The mean stress was reduced putting almost the entire floorbeam live load stress cycles into compression.
2. Due to low thermal expansion of the CFRP plates, an increase in temperature resulted in an increase in the pre-stress in the CFRP.
3. Humidity did not affect the performance of the CFRP plates.

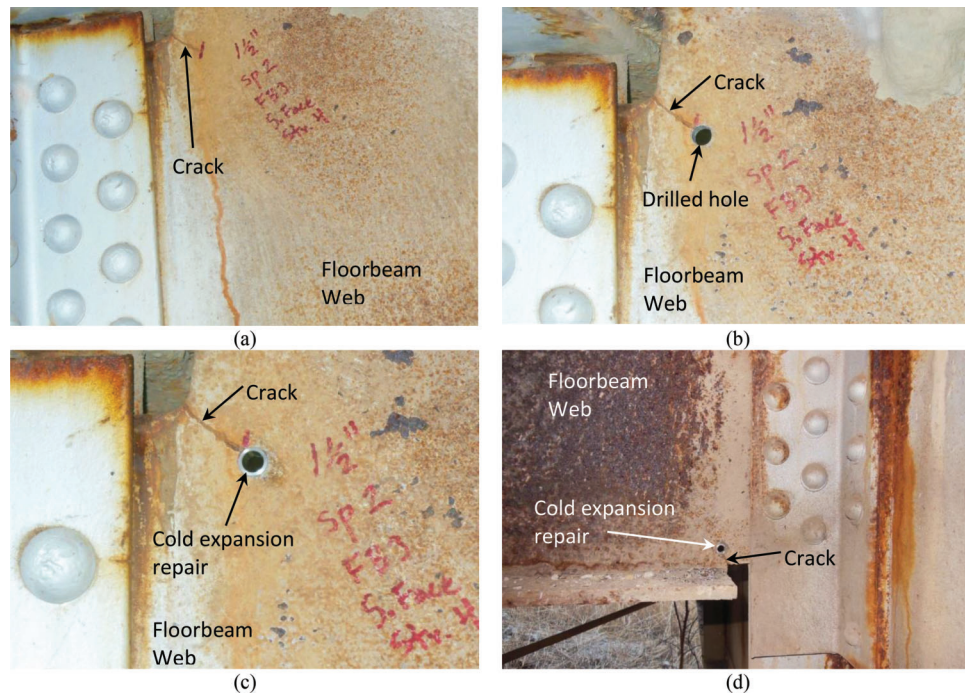
Figure 8.7 Cold expansion of crack arrest holes (a) floorbeam cope cracking, (b) drilled hole at the crack tip, (c) & (d) finished repairs with expansion sleeve (Photographs courtesy of Oklahoma DOT).

Figure 8.7 shows the progressive steps of installing one of the cold expansion sleeves at floorbeam cope details that have fatigue cracked. Notice that the expansion sleeve is left behind providing a direct interception as the base material attempts to rebound, or spring back, helping to lock in the residual compressive stress at the edge of the hole. Although this method shows promise for bridge repair applications and is being implemented by a few states, the repair has not yet been in service long enough to determine its long-term effectiveness.
